Challenges in risk assessment Insidious erosion of safety margins over time

Insidious erosion of safety margins over time

Alaska Airlines flight 261

Loss of Control and Impact with Pacific
Ocean Alaska Airlines Flight 261
McDonnell Douglas MD-83, N963AS
About 2.7 Miles North of
Anacapa Island, California
January 31, 2000

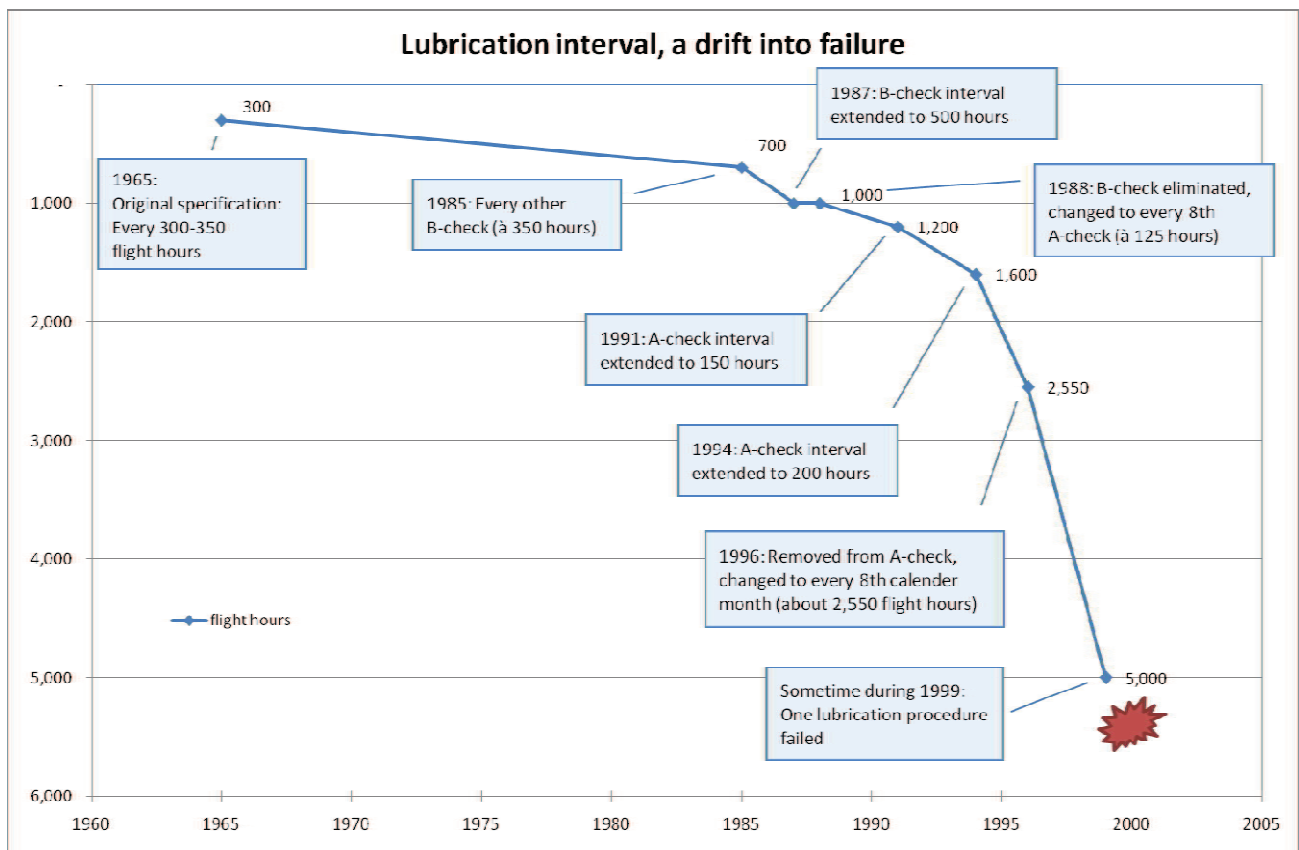
The immediate technical cause for this crash relates to inadequate lubrication of a critical component in the tail section of the jet. The graph below shows how processes of drift hollowed out the margins of safety originally engineered into the system, to the extreme point where a single failed lubrication procedure, in this case caused by a careless mechanic, would lead to catastrophic failure.

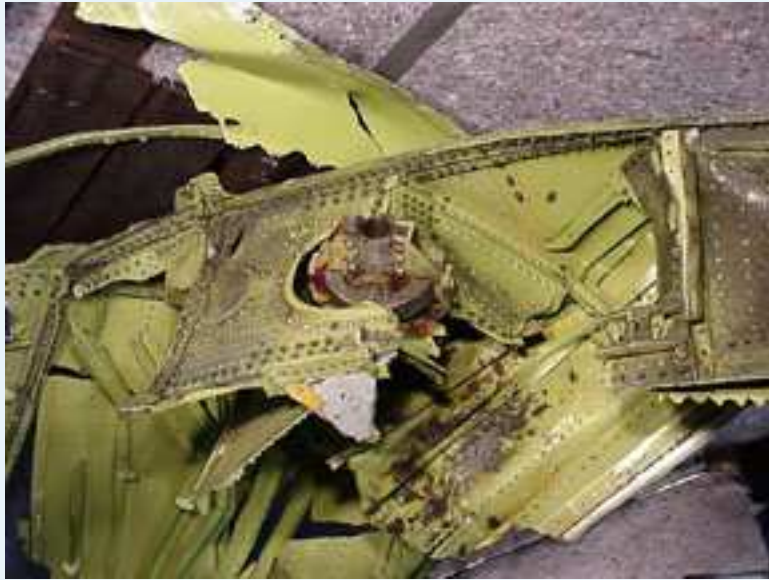
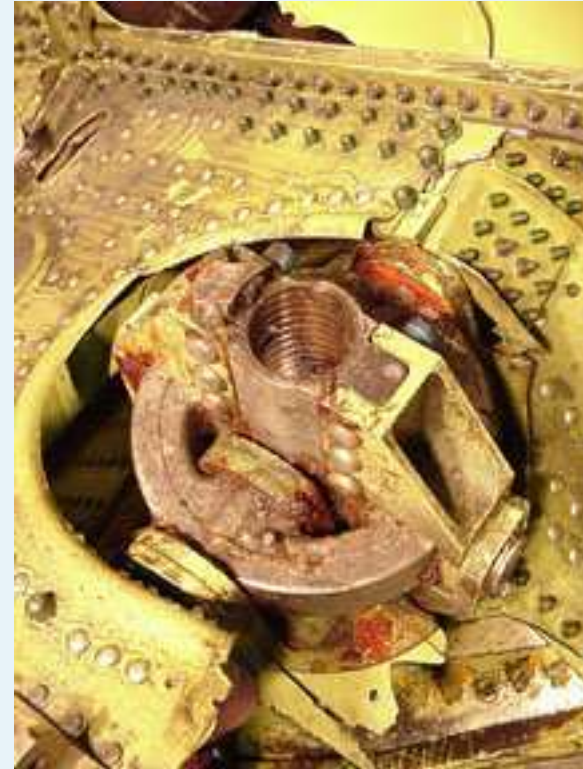
Gimbal nut from Alaska Airlines flight 261, shown below as attached to front spar of stabilizer from the aircraft's tail, and in close-up

Acme nut severely worn

Approximately 90 percent of the thread thickness had worn away before the remainder of the threads sheared off.

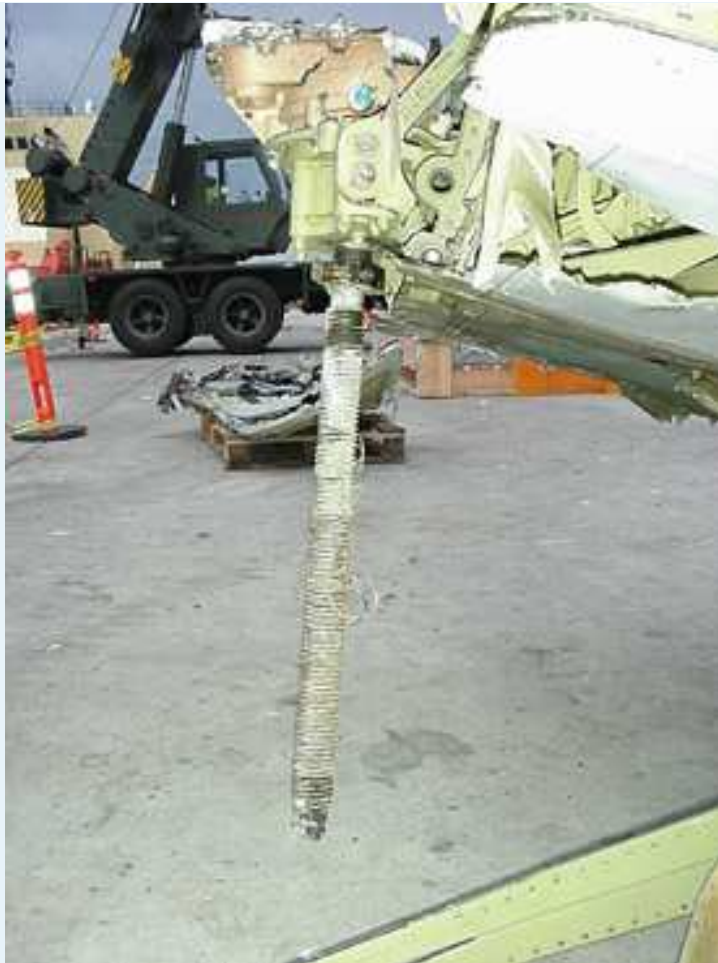
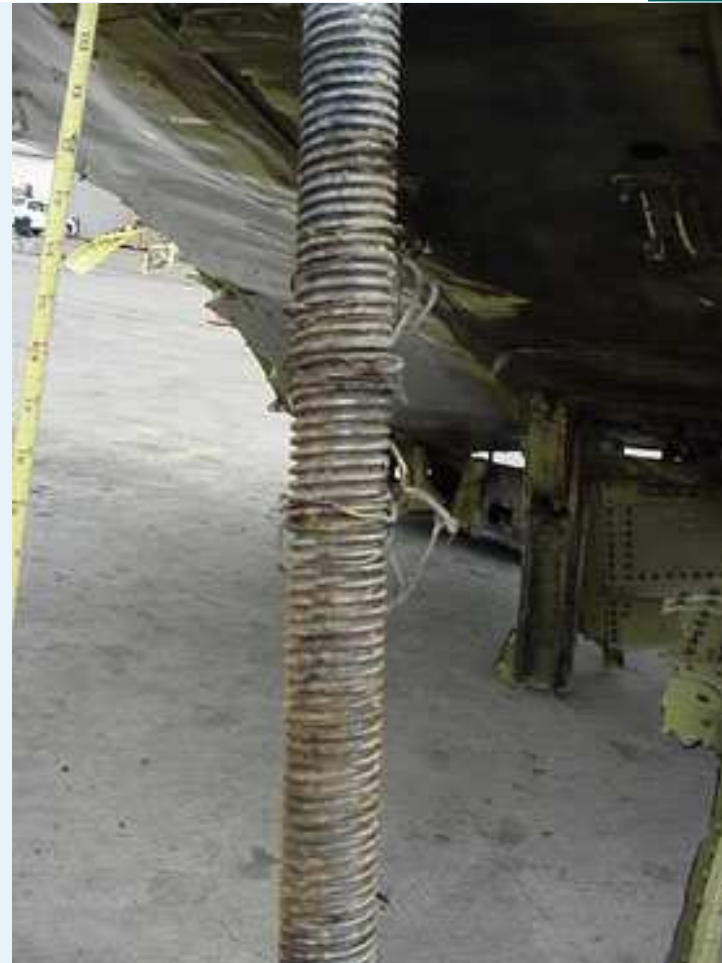
Jackscrew from horizontal stabilizer of Alaska Airlines flight 261, recovered from the wreckage

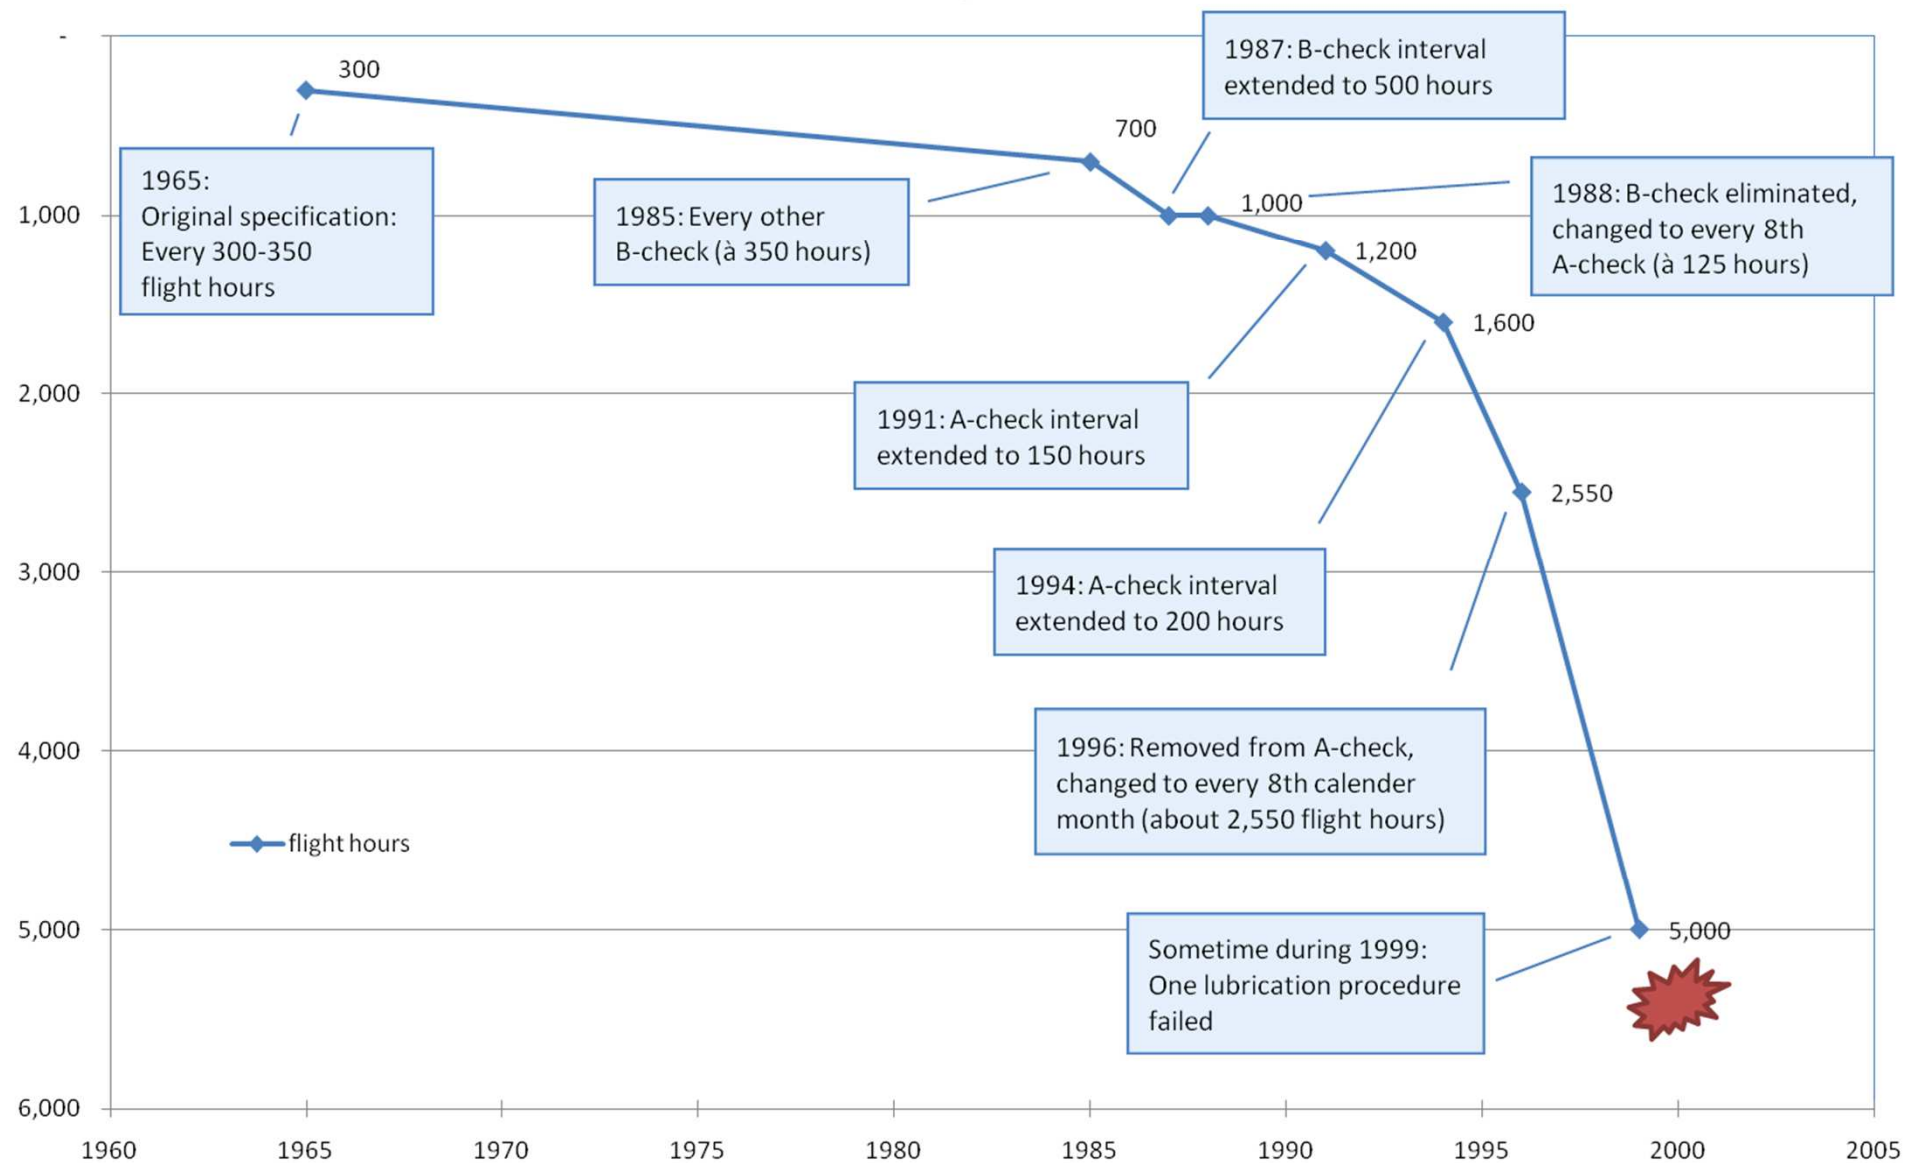
Lubrication interval, a drift into failure

- Preventive measure:
- Alaska Airlines, with FAA approval, increased the **lubrication interval** from 500 flight hours to every eight calendar months. (wear is a function of aircraft usage, not calendar time). (decreases the tolerance for missed or inadequate lubrication).
- Risk control measure:
- The **thread wear check** to determine the airworthiness of the jackscrew assembly was required at every other C check. However, the C check interval was extended.

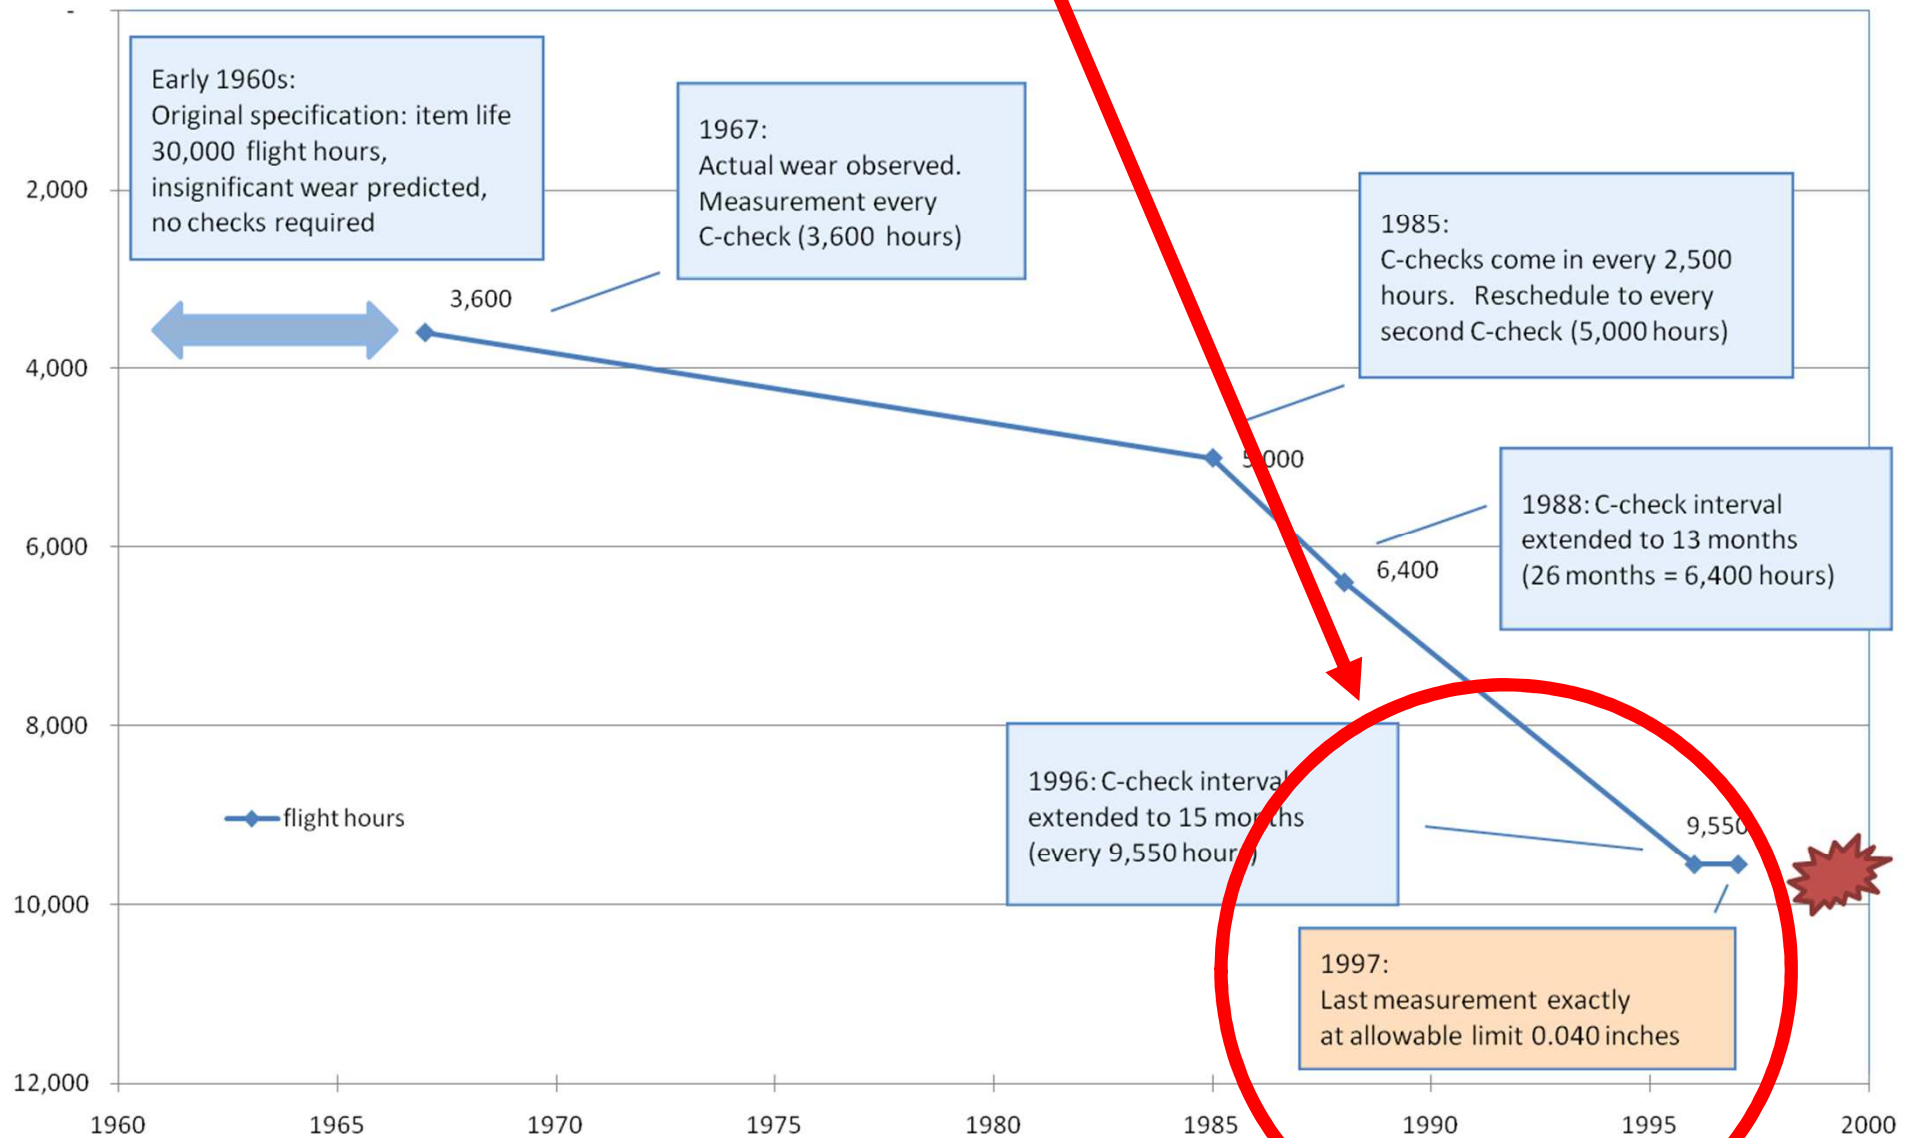
The last thread wear measurement

Accident airplane's last thread wear check - 1997

"Horizontal Stab - acme screw and nut has maximum allowable end play limit (.040 in.)." The planned action box, which was filled out by the day-shift lead mechanic and inspector, stated, **"Replace nut and perform E.O. 8-55-10-01."**

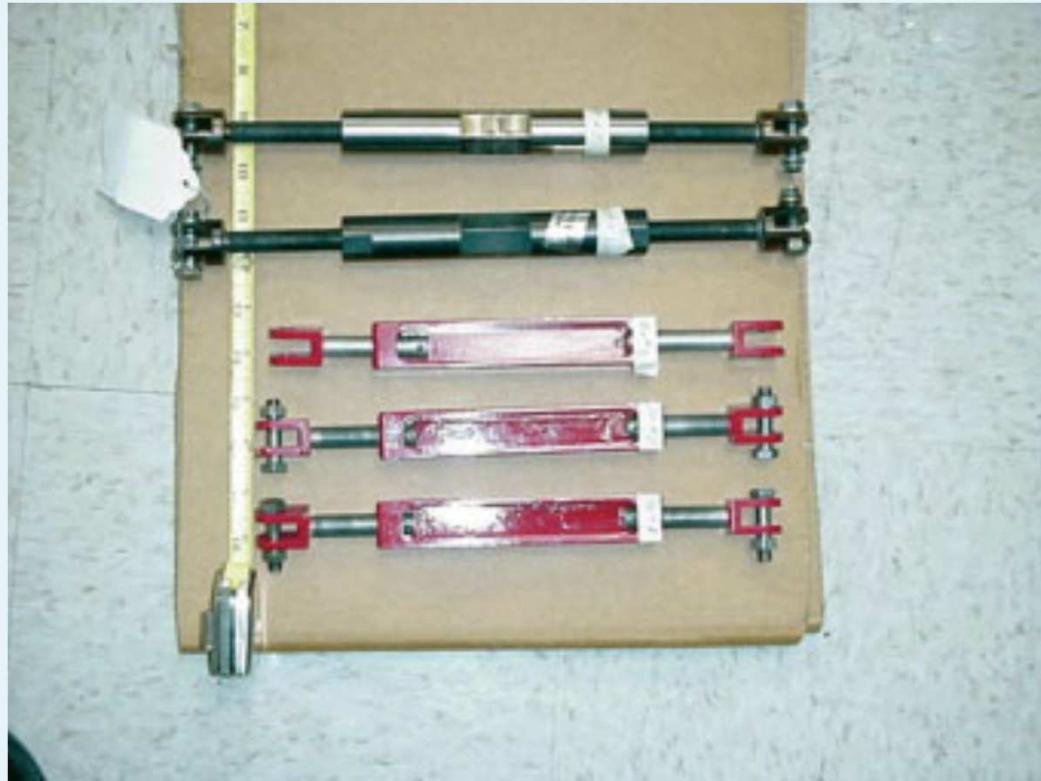
- Up until the time of the accident, Alaska Airlines had only one restraining fixture in its inventory. The fixture was manufactured in-house...
- During several of these tests, the in-house restraining fixtures yielded lower end play measurements ...

Two Alaska Airlines-fabricated restraining fixtures and three Boeing manufactured fixtures

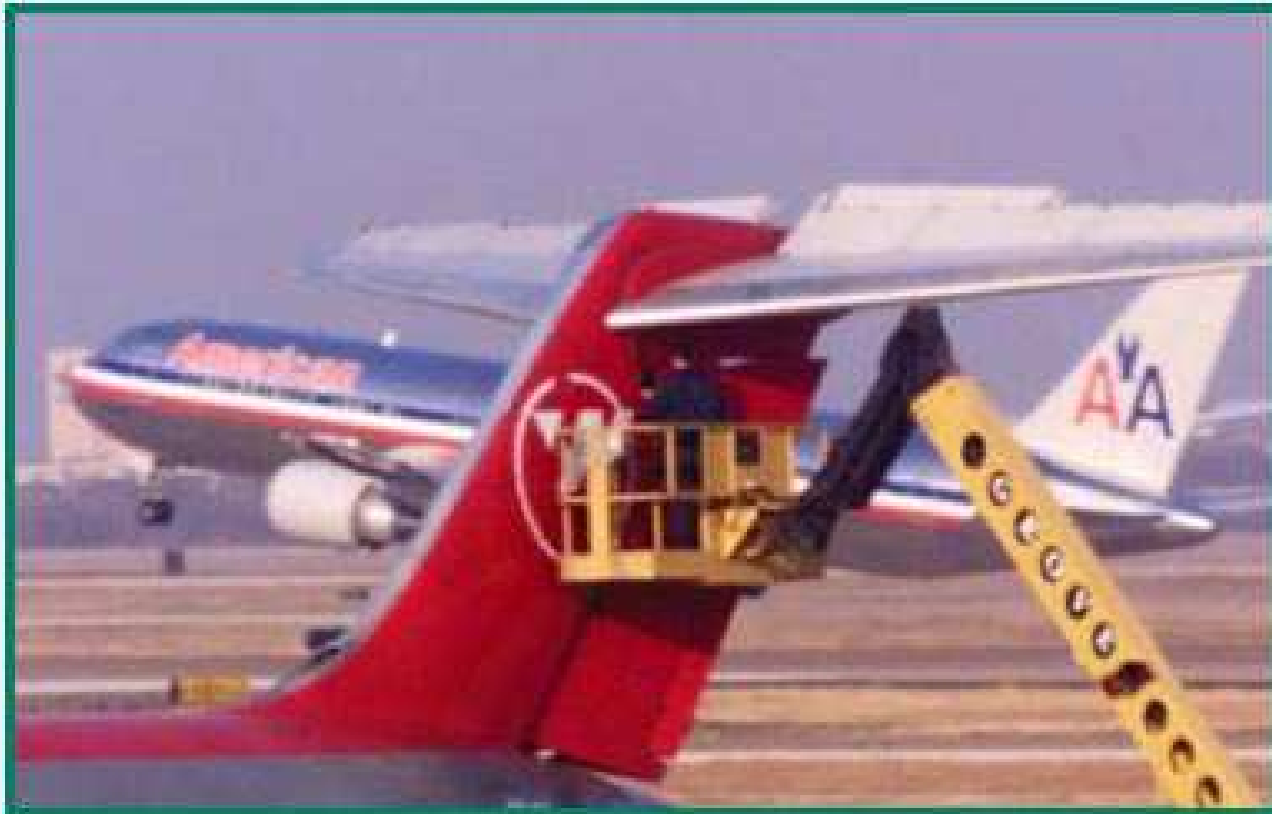
Lubrication maintenance access

Photograph showing maintenance on the horizontal stabilizer of a Northwest Airlines MD-83 aircraft. An American Airlines aircraft is in the background

Recommendation: Increase the size of the access panel to accomplish the lubrication procedures.
